Rep.№5601894,54G-0917 26th January 2023 Fuji Electric FA Components & Systems Co., Ltd. Development Dept

US bus bar test result

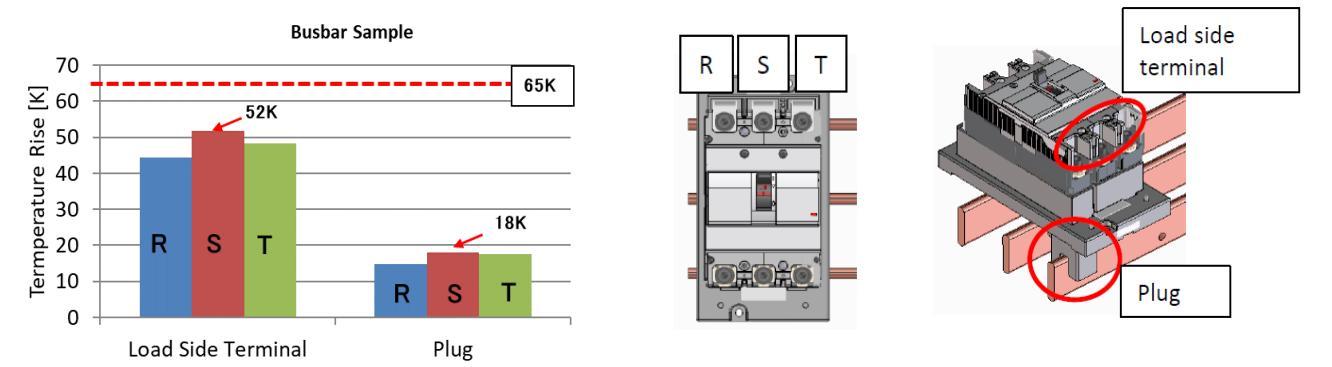
Firgure 1 Temperature rise test result

OFigure 1 shows the results of the temperature rise test (BW50RBGU) during energization. Test condition: 50A R-S-T energized, temperature rise value measured at load side terminal and plug contact part.

The temperature rise of the plug in at 100% rated current in load side terminal and the plug-in adapter is 52K and 12 K which can fufill the required standard.

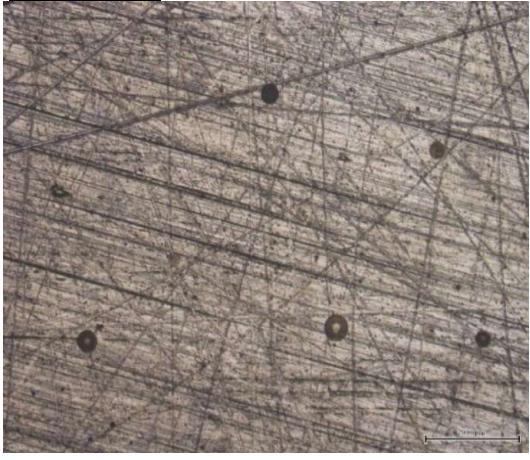
Busbar Surface

There is processing marks and nodule marks on the surface, which may be a cause of plating peeling during insertion and removal .Lower level of busbar surface roughness is recommended during busbar processing.

In the busbar sample, many traces of processing and nodules during rolling are observed on the surface.

It is believed that these are the causes of the increase in the unevenness of the surface.

Bright electro-nickel is recommended after reducing the surface roughness of the busbar base material (copper) and taking measures to suppress nodules.
