## US bus bar test result

In the development of the Lambda Plug-in project, sample busbar with the US local standard is tested.  
Based on the test result of the combination of Lambda Plug-in product and the busbar, we would verify and recommend the busbar specification to customer.

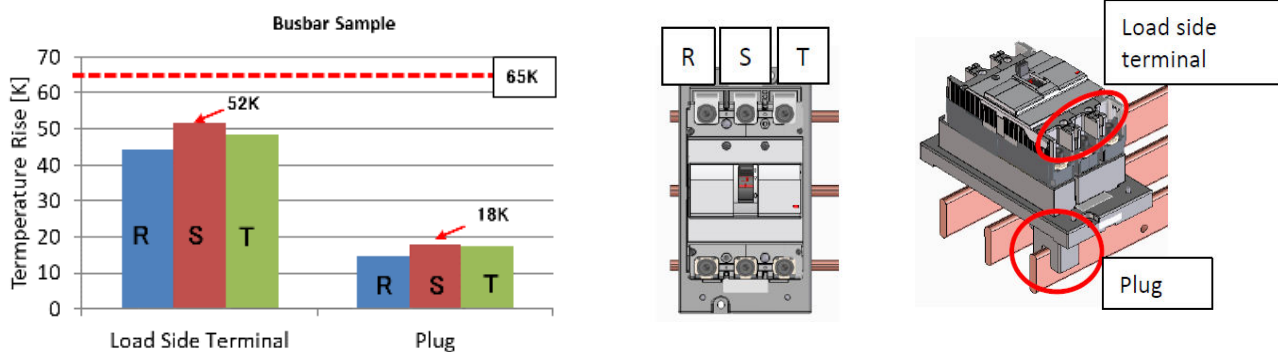
**Figure 1 Temperature rise test result**

○Figure 1 shows the results of the temperature rise test (BW50RBGU) during energization.  
Test condition: 50A R-S-T energized, temperature rise value measured at load side terminal and plug contact part.

The temperature rise of the plug in at 100% rated current in load side terminal and the plug-in adapter is 52K and 18 K which can fulfill the required standard.

The temperature rise of the contact at rated 100% current is less than the required standard value. (Test result: Pass)

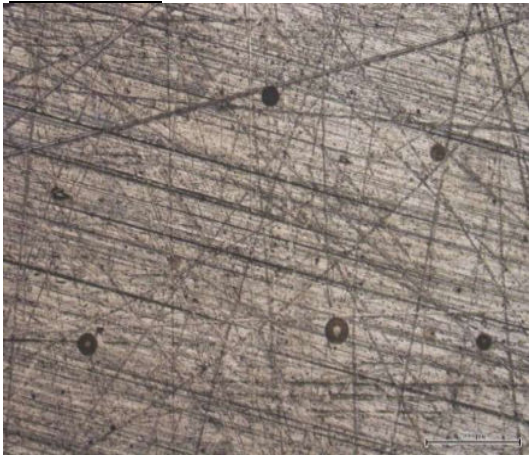
Microscope

In the busbar sample, many traces of processing and nodules during rolling are observed on the surface.

It is believed that these are the causes of the increase in the unevenness of the surface.

**Busbar Surface**

There is processing marks and nodule marks on the surface, which may be a cause of plating peeling during insertion and removal. Lower level of busbar surface roughness is recommended during busbar processing.

Bright electro-nickel is recommended after reducing the surface roughness of the busbar base material (copper) and taking measures to suppress nodules.
